DOT/FAA/82-156

FIRE CONTAINMENT CHARACTERISTICS OF AIRCRAFT CLASS D CARGO COMPARTMENTS

David R. Blake
Richard G. Hill

Final Report

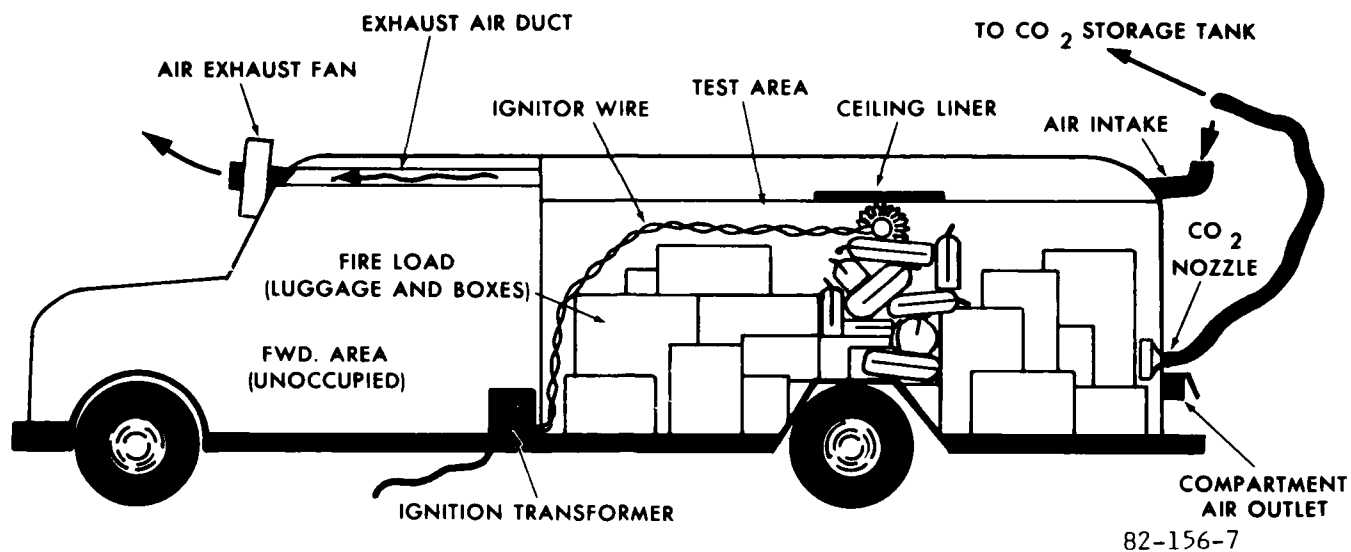
FIGURE 6. SIDEVIEW OF TYPICAL FIRE LOAD

leakage rate and liner type. Other variables that affected the fire growth and intensity were: the type of luggage burning, the humidity, the type and density of the packed clothing and the configuration of the fire load. Figure 6 shows a typical fire load.
